Testing incident. 15 injured, one fatality

A good example of the potential dangers associated with pneumatic testing.

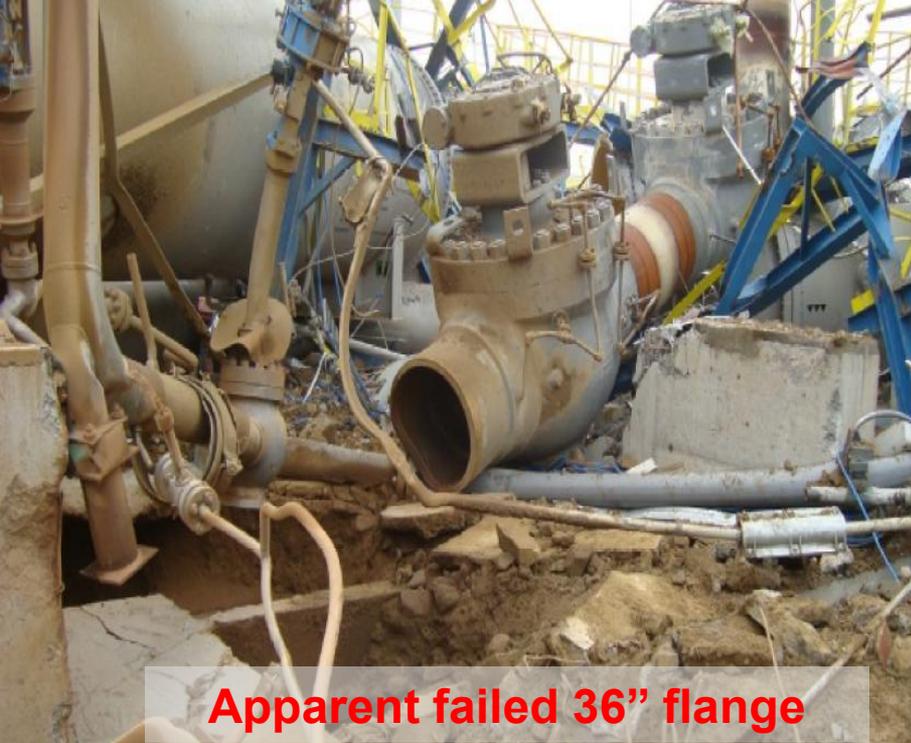
The explosion was caused by a sudden flange failure while the workers were conducting pneumatic testing of a 36 inch diameter line, 600m long segment, laid out in an S shape. The testing pressure was 15.6MPa (2,262psi), and the explosion occurred when the system pressure reached 12.3 MPa (1,784psi). The explosion was caused by the rupture of a flange at the end of the test section. The 2nd and 3rd last pictures in the attachment show the face of rupture. The flange was for future connection.

The rupture occurred in the flange body, 30 to 40 mm from the flange to pipe weld. It's a "clean" break, i.e., brittle failure. The cause of the flange failure was under investigation. The worker killed by a piece of flying scaffold pipe was outside the entrance door to the dorm (not lying in his bed according to news below), 350 m away from the explosion. The injured workers were about 100m away from the explosion (installing insulation). The explosion is likely to delay start up of the project by 6 months. The LNG terminal was to be ready to receive shipment in a couple of months.

Apparent failed 36" flange
