Testing incident. 15 injured, one fatality

A good example of the potential dangers associated with pneumatic testing.

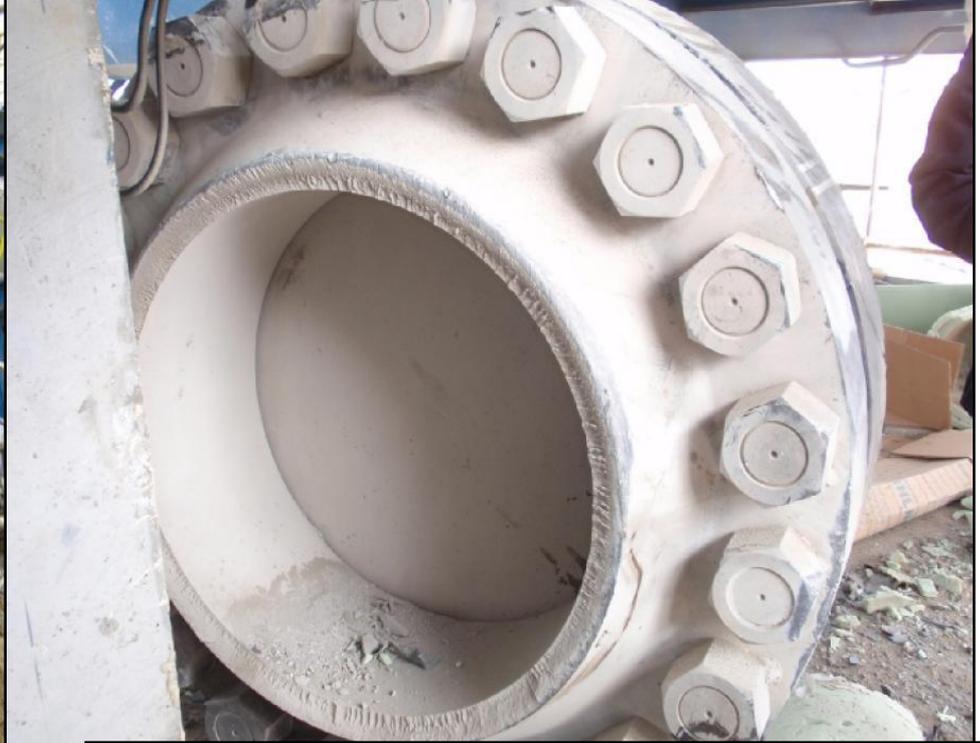
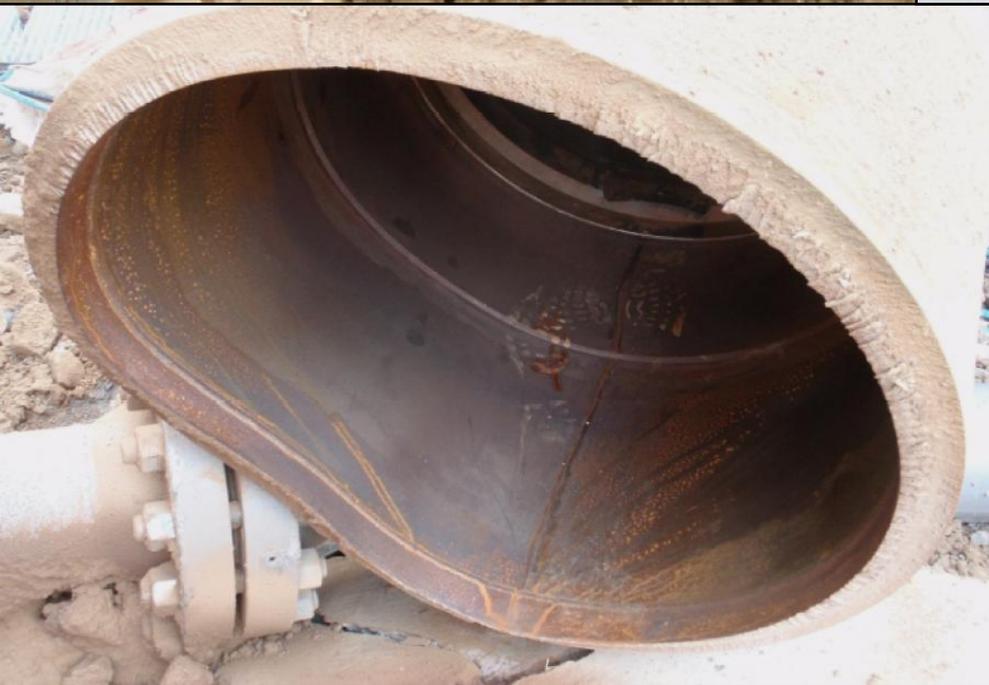
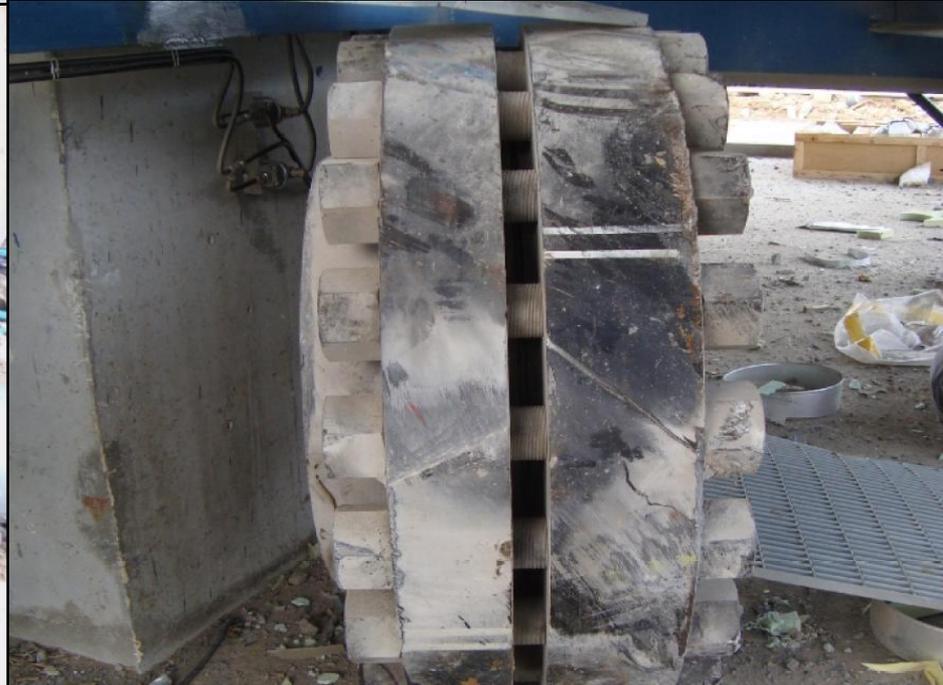
The explosion was caused by a sudden flange failure while the workers were conducting pneumatic testing of a 36 inch diameter line, 600m long segment, laid out in an S shape. The testing pressure was 15.6MPa (2,262psi), and the explosion occurred when the system pressure reached 12.3 MPa (1,784psi). The explosion was caused by the rupture of a flange at the end of the test section. The 2nd and 3rd last pictures in the attachment show the face of rupture. The flange was for future connection.

The rupture occurred in the flange body, 30 to 40 mm from the flange to pipe weld. It's a "clean" break, i.e., brittle failure. The cause of the flange failure was under investigation. The worker killed by a piece of flying scaffold pipe was outside the entrance door to the dorm (not lying in his bed according to news below), 350 m away from the explosion. The injured workers were about 100m away from the explosion (installing insulation). The explosion is likely to delay start up of the project by 6 months. The LNG terminal was to be ready to receive shipment in a couple of months.

Apparent failed 36" flange

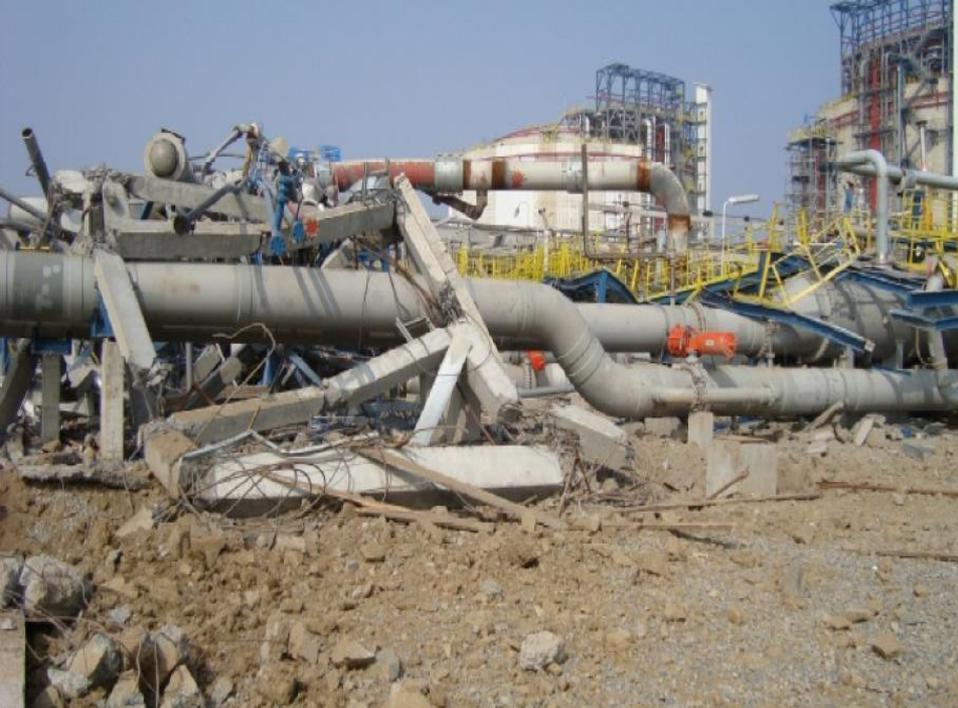
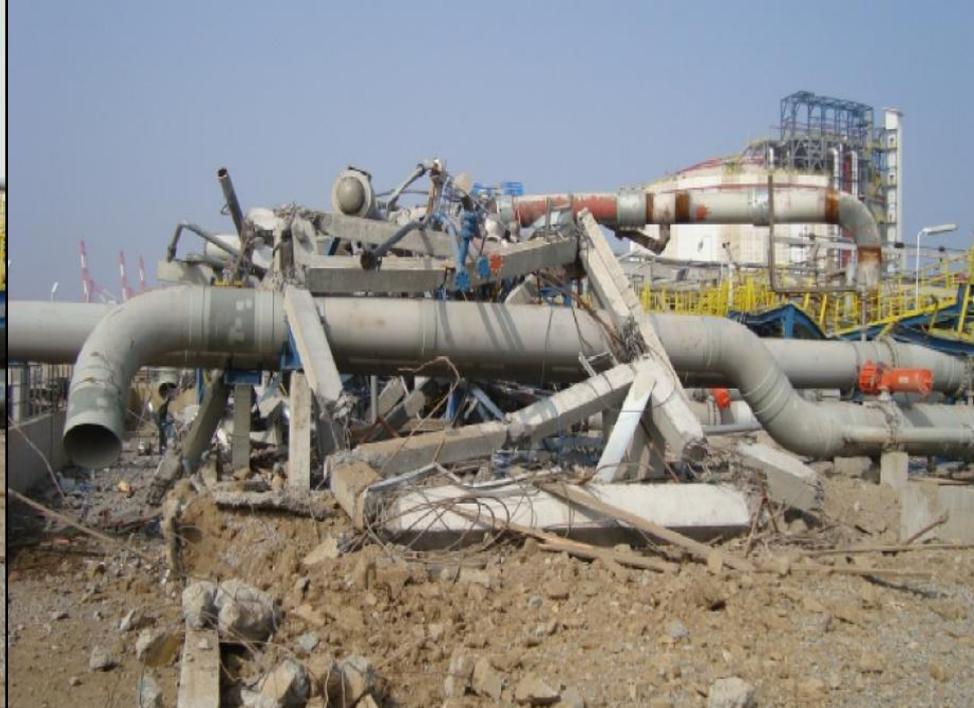
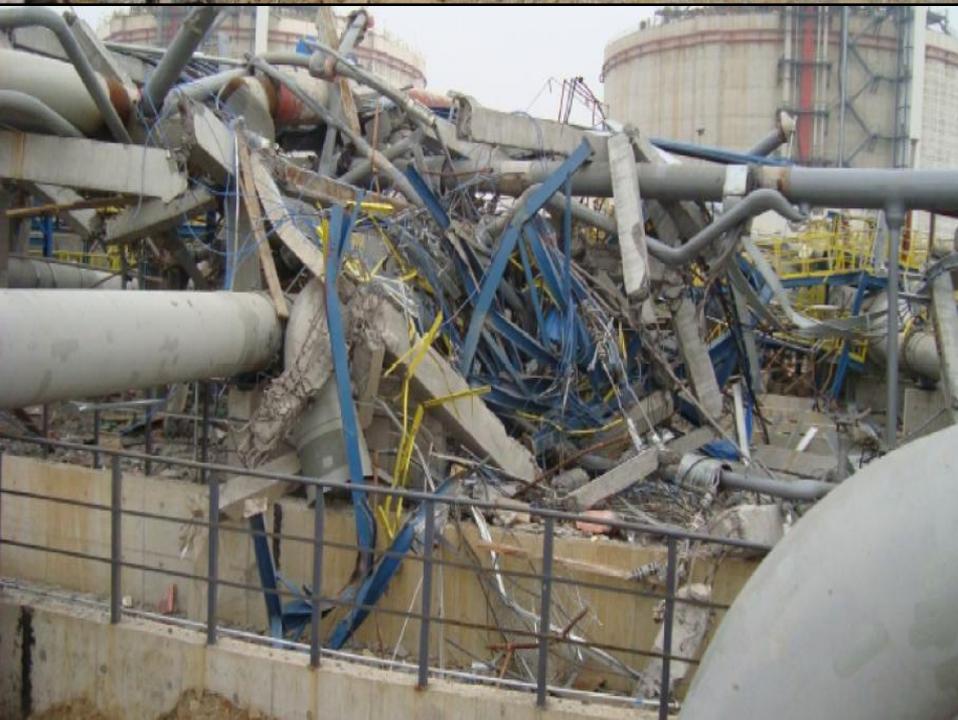
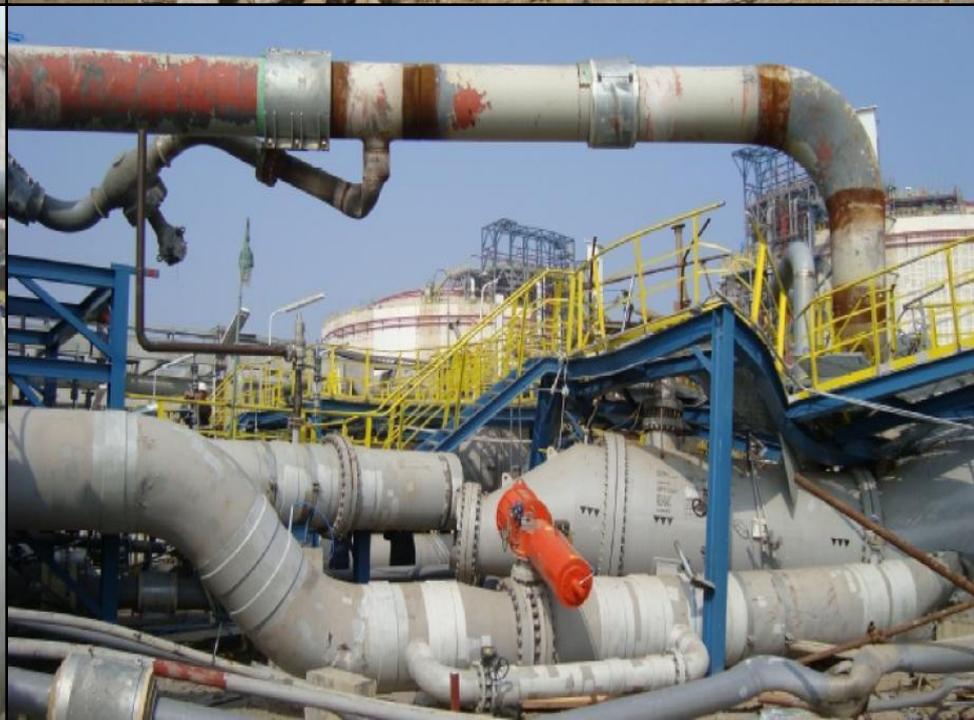
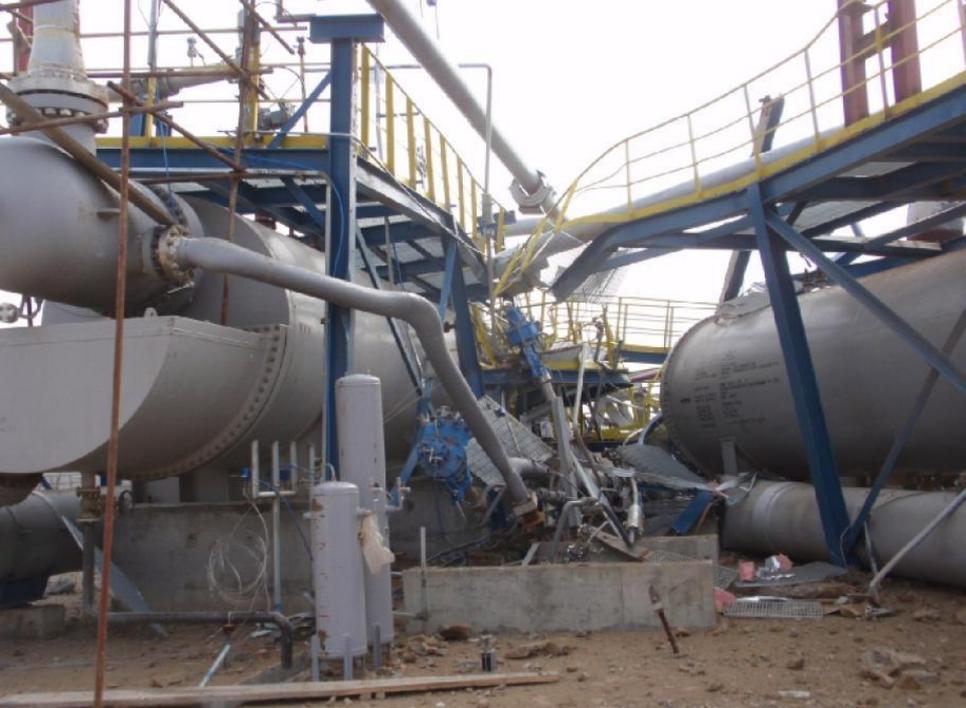
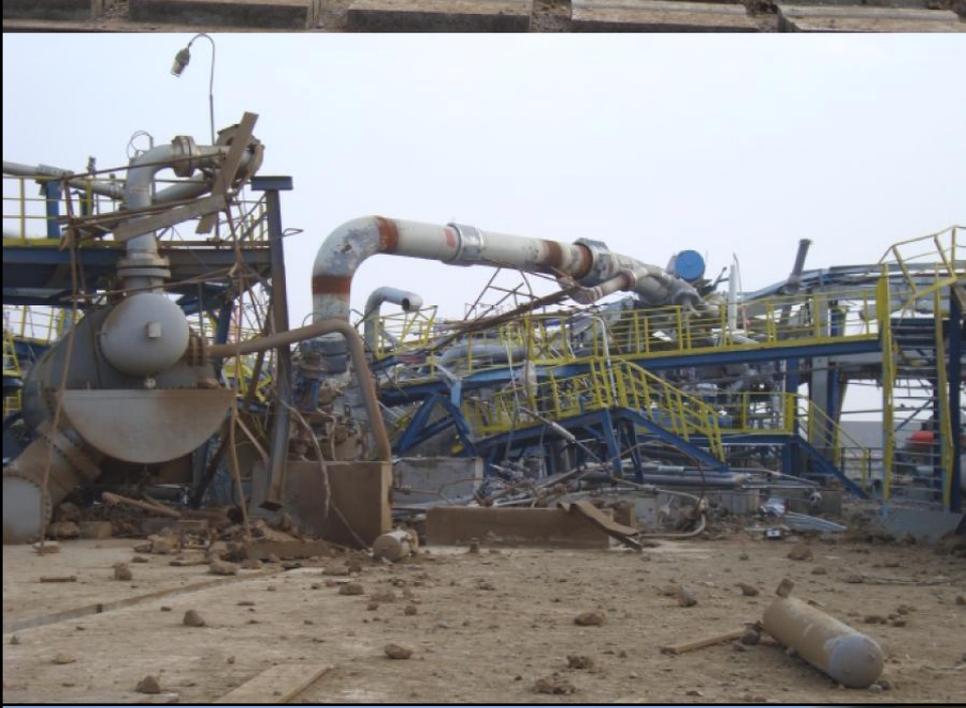
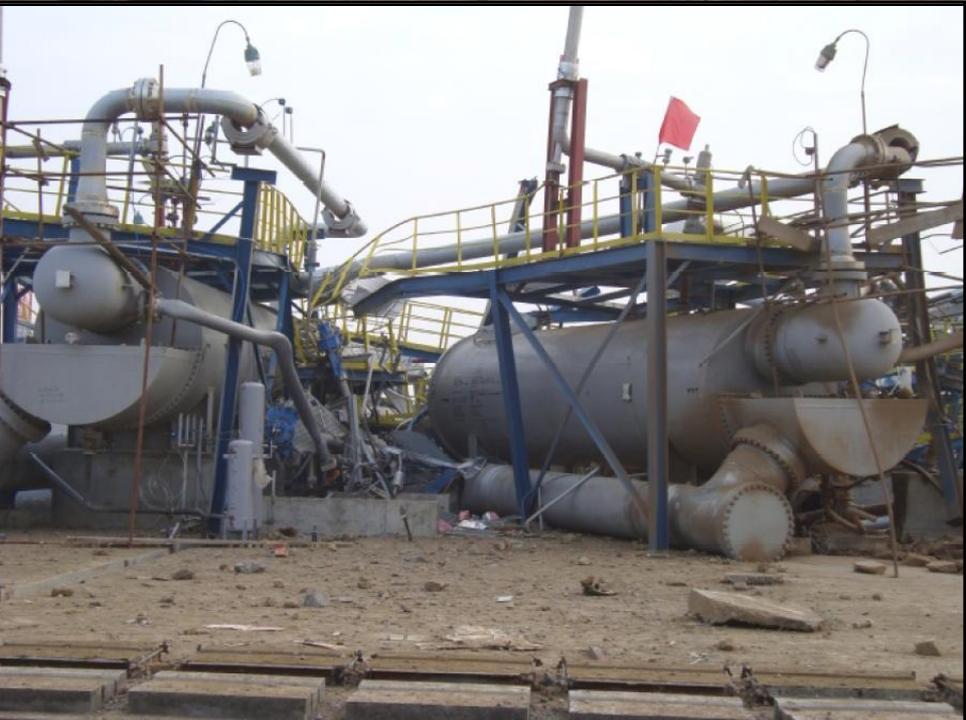
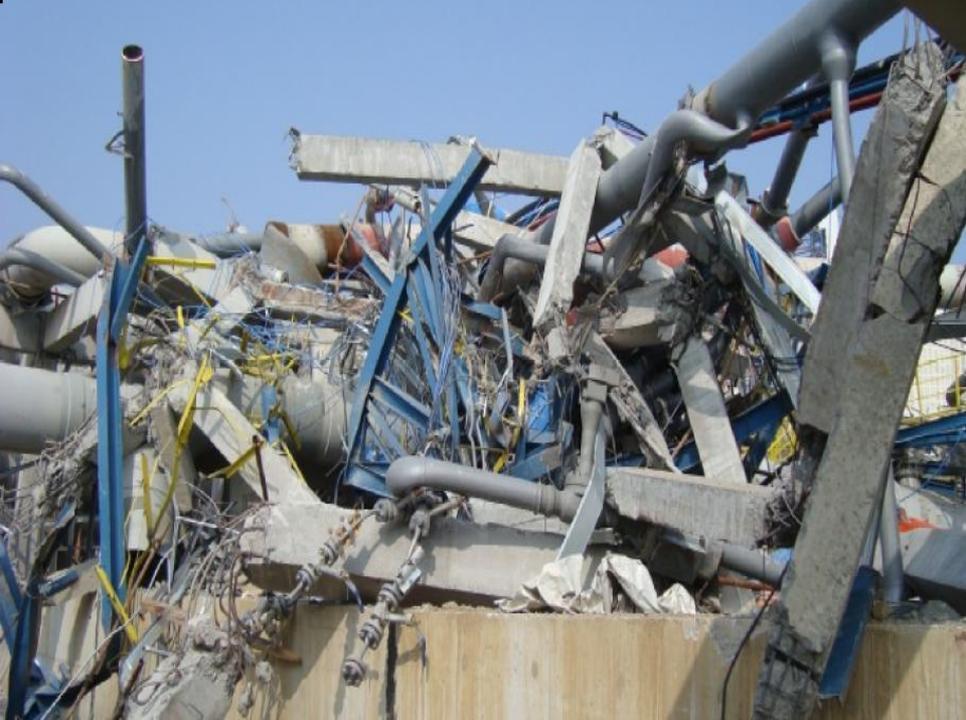
The explosion occurred when workers were adjusting equipment, according to a spokesman for the municipal work safety authority. The men were working on a liquefied natural gas terminal that is expected to receive 3 million tons of the fuel annually after the first phase becomes operational this year. When the facility is finished, LNG shipped by sea from Malaysia will be transformed into a gaseous state and sent to downtown Shanghai through pipes. The explosion occurred during a pressure test of the equipment, according to the city government media office. Workers were pumping air into a gasifier when some 500 meters of the piping network burst into fragments, buckling cement crossbeams.
